DEPARTMENT OF TRANSPORTATION

Quality Assurance and Source Inspection

Contract #: 04-0120F4Cty: SF/ALA Rte: 80 PM: 13.2/13.9File #: 69.28**WELDING INSPECTION REPORT****Resident Engineer:**Siegenthaler, Peter**Address:** 333 Burma Road**City:** Oakland, CA 94607**Report No:** WIR-022067**Date Inspected:** 30-Nov-2010**Project Name:** SAS Superstructure**OSM Arrival Time:** 700**Prime Contractor:** American Bridge/Fluor Enterprises, a JV**OSM Departure Time:** 1900**Contractor:** Zhenhua Port Machinery Company, Ltd (ZPMC), Changxing Island **Location:** Shanghai, China**CWI Name:** Geng Wei, Qiu Wen**CWI Present:** Yes No**Inspected CWI report:** Yes No N/A**Rod Oven in Use:** Yes No N/A**Electrode to specification:** Yes No N/A**Weld Procedures Followed:** Yes No N/A**Qualified Welders:** Yes No N/A**Verified Joint Fit-up:** Yes No N/A**Approved Drawings:** Yes No N/A**Approved WPS:** Yes No N/A**Delayed / Cancelled:** Yes No N/A**Bridge No:** 34-0006**Component:** OBG**Summary of Items Observed:**

BAY 14, OBG (NWIT # 7561)

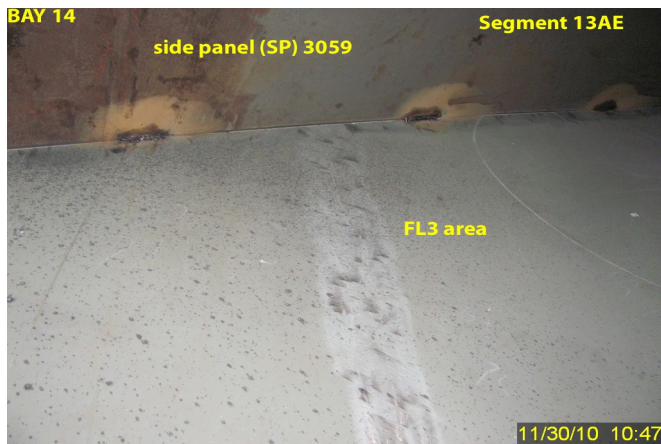
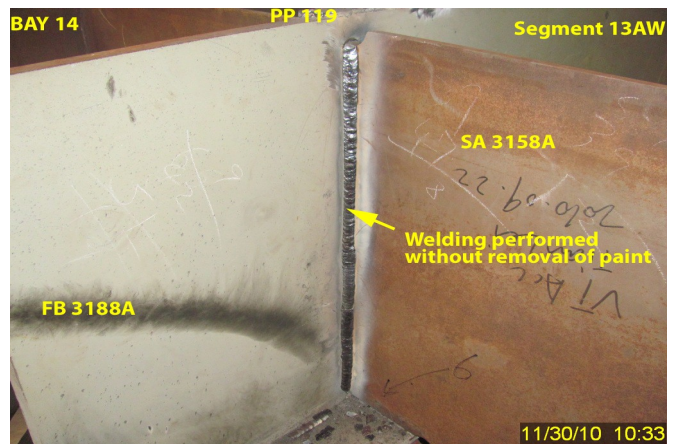
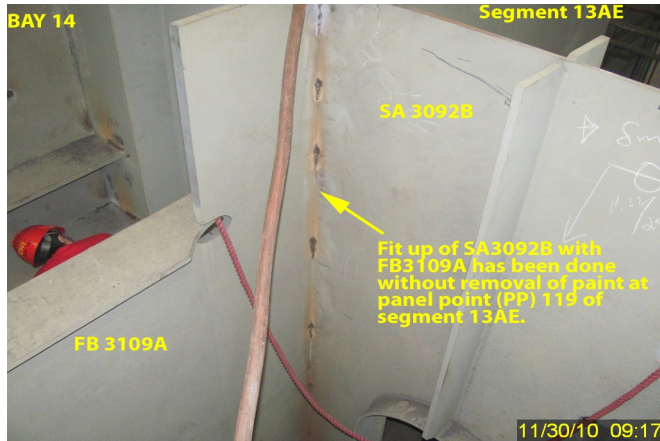
During the Quality Assurance in process visual inspection of OBG lift 13, this Quality Assurance (QA) Inspector discovered the following issues:

Segment 13AW:

- The welding and fit up has been carried out without the removal of primer undercoat from the surface of the material during assembly.
- The components are identified as follows:
 - Sub-assemblies SA3180B, SA3181B and SA3158B joining to Floor Beam FB3192A at panel point 119+1500.
 - Sub-assemblies SA3180A, SA3181A, SA3158A, SA3180B, SA3181B and SA3158B joining to Floor Beam FB3188A at panel point 119.
 - Sub-assemblies SA3180A, SA3181A and SA3158A joining to Floor Beam FB3185A at panel point 119-1500.

- Sub-assemblies SA3185A, SA3185B, X4445A and X4445B joining to side panel SP3091 at the FL3/Cross Beam side.

Segment 13AE:

-The welding and fit up has been carried out without the removal of primer undercoat from the surface of the material during assembly.

-Dry film thickness (DFT) measurements taken in way of the welded and fit-up members averaged 120µm

-Attached photographs provide additional location and details.
